New York State Department of Transportation

Yellow Flag NB22CTW005

BIN: 1065318

Location: Span 129 Girder G5 at Pier 128

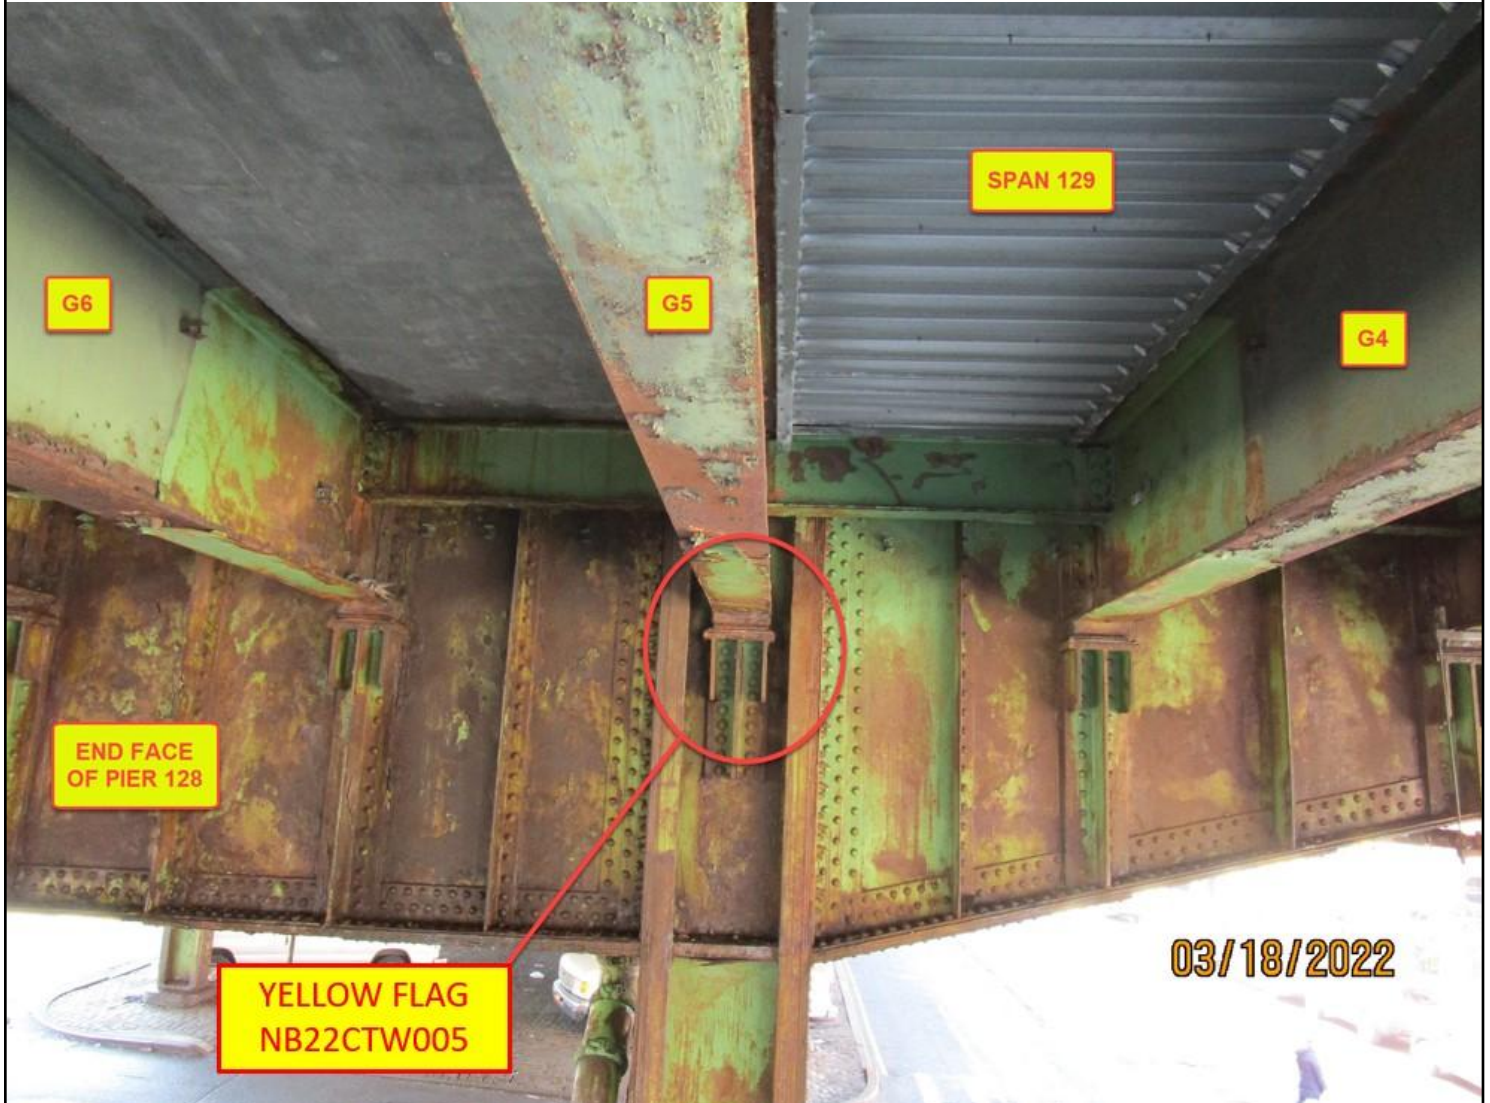
Photo Number: 1

Description: The end of Girder G5 in Span 129 at Pier 128 exhibits severe corrosion resulting in an overall web bearing area section loss of approximately 40% (previously 41%) and an overall shear web area section loss of approximately 21% (no change) with an average overall localized section loss of approximately 53% (no change) for 6"L x 5"H area directly above the bearing below the guide angle (Photos 2 and 3). Also, the lower web of the girder adjacent to the web bearing area exhibits an average of 20% section loss for 2'L x 3"H above the bottom flange. In addition, both edges of the bottom flange exhibit 30% section loss for 2'L x 3"W above the bearing area. There is no significant change in the condition since the last inspection. (Refer to sketch for more details)

Attachment Description: General view of the flagged condition at Girder G5 in Span 129 at Pier 128. Looking Begin.

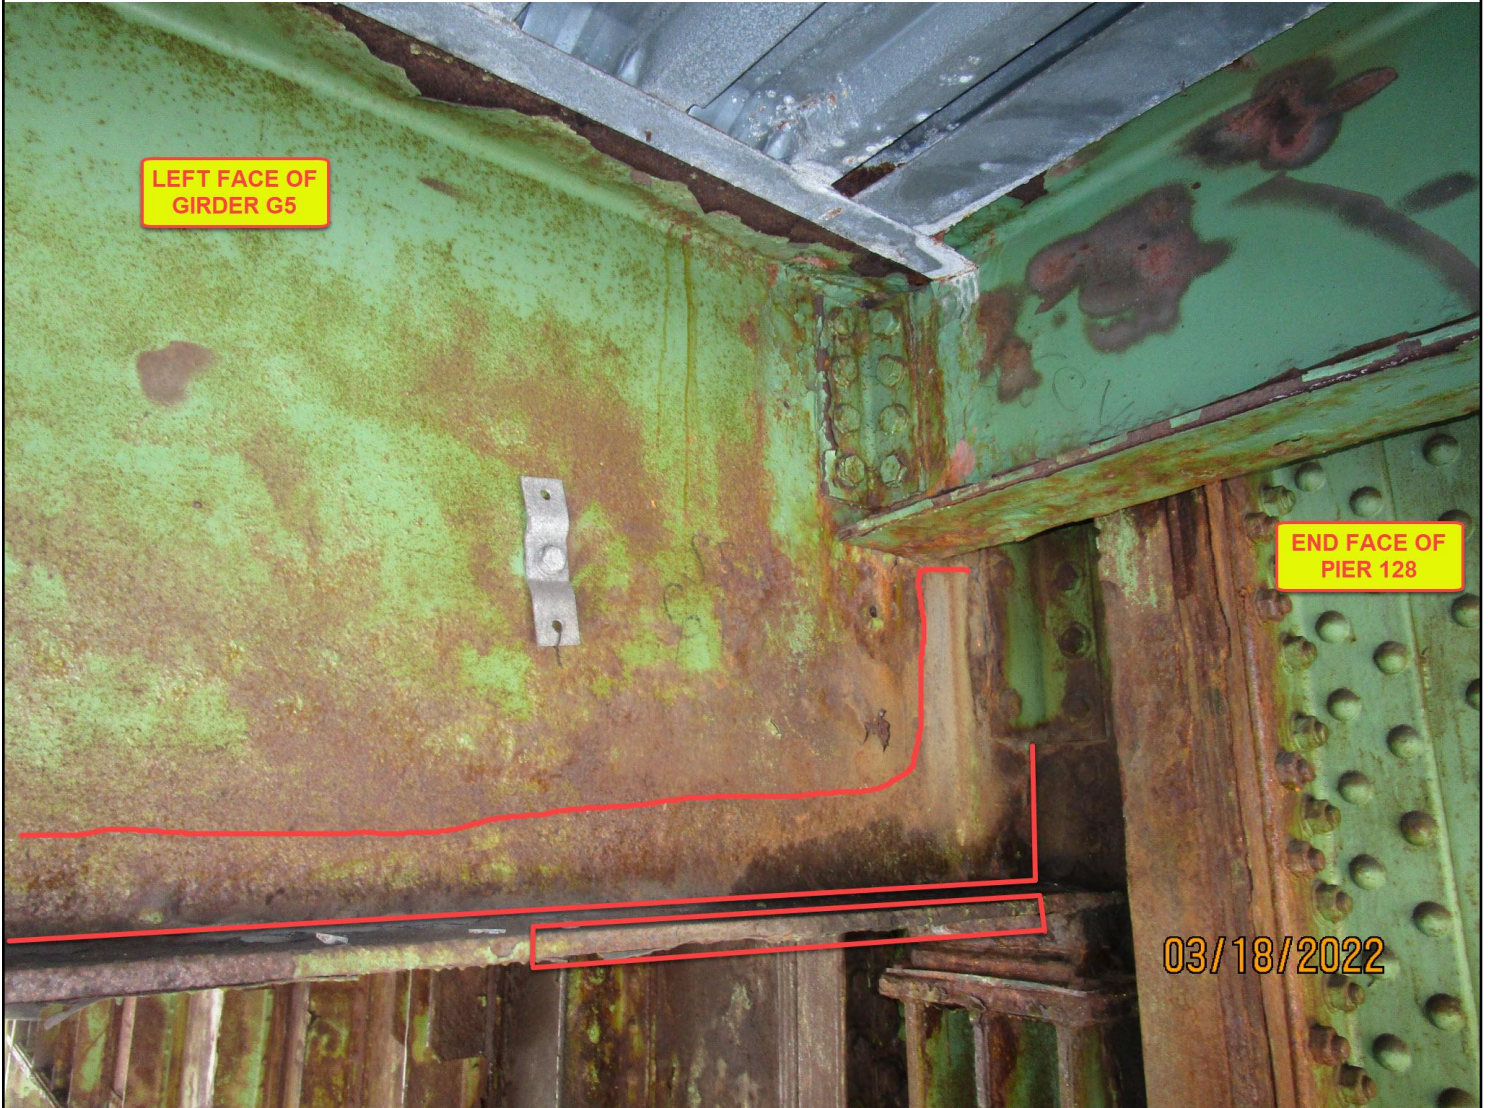
Photo Number: 2

Attachment Description: The left face of Girder G5 in Span 129 at Pier 128. The end of the girder exhibits severe section loss in the lower web above the bottom flange at the bearing as well as the web height adjacent to the guide angle. Looking Begin and Right.

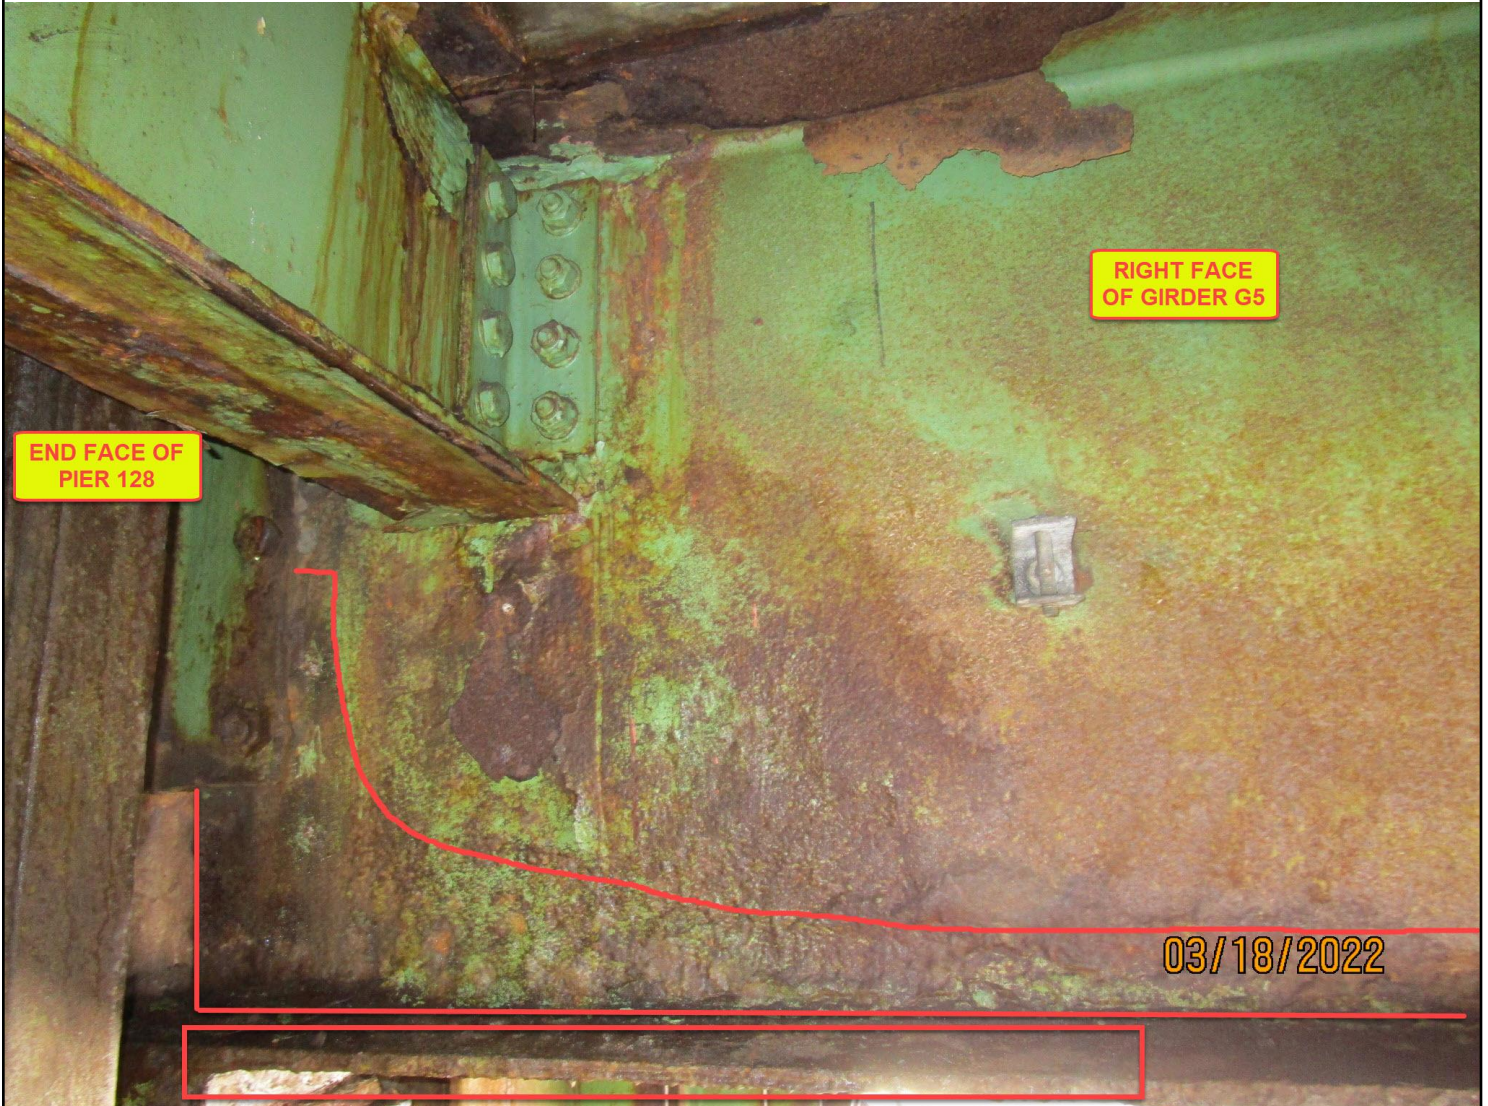
Photo Number: 3

Attachment Description: The right face of Girder G5 in Span 129 at Pier 128. The end of the girder exhibits severe section loss in the lower web above the bottom flange at the bearing as well as the web height adjacent to the guide angle with edge section loss at the bottom flange. Looking Left.

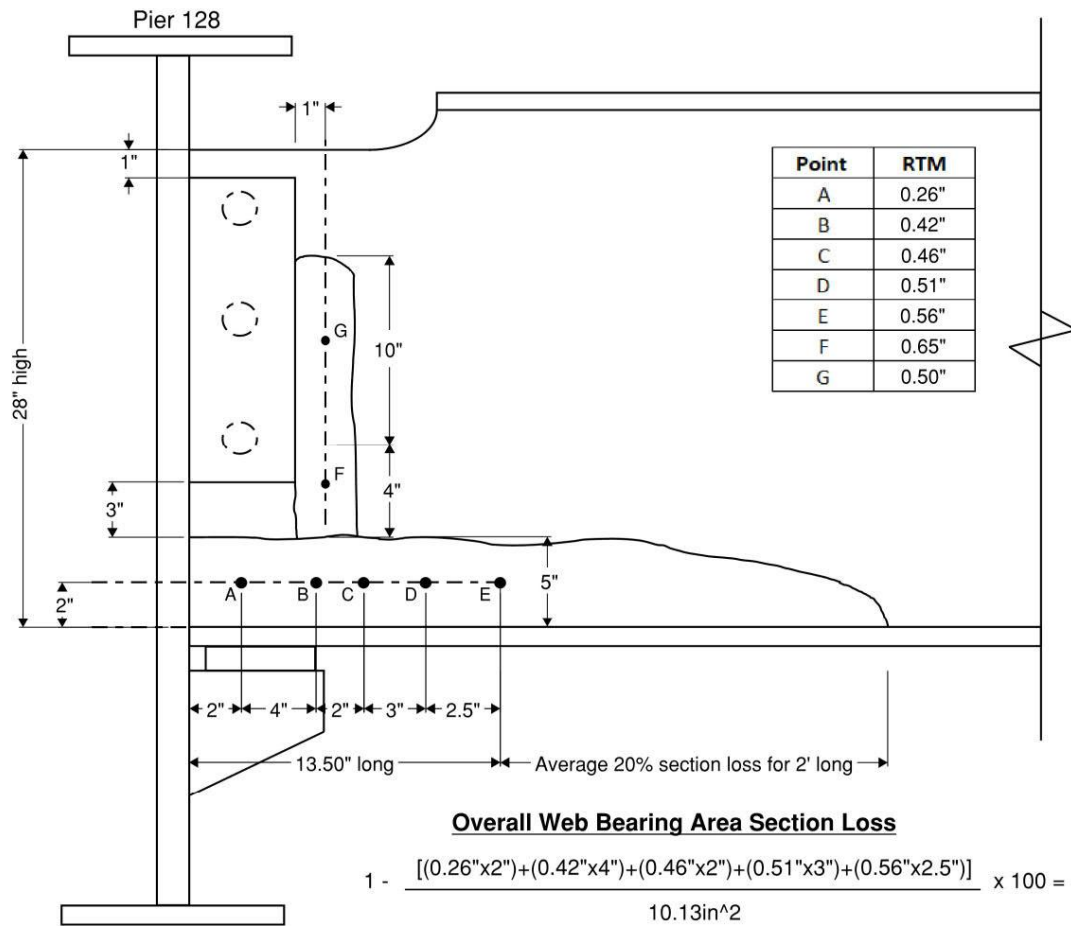
Right Face of Girder G5 Sketch in Span 129 at Pier 128

**Overall Shear Web Area Section Loss**

$$1 - \frac{[(0.42" \times 5") + (0.65" \times 4") + (0.50" \times 10") + (0.75" \times 9")]}{21 \text{ in}^2} \times 100 = 21\%$$

- As-built web thickness = 0.75"
- Length of bearing area = 18 x web thickness = 18 x 0.75" = 13.50"
- Overall bearing area = 13.50" x 0.75" = 10.13 in²
- As-built shearing web area = 28" x 0.75" = 21 in²
- Adjacent Girder G4 exhibits up to 35% section loss at the lower web above the bottom flange and for the full web height adjacent to the guide angles
- Adjacent Girder G6 exhibits up to 30% section loss at the lower web above the bottom flange and 20% section loss for the full web height adjacent to the guide angles
- Both edges of the bottom flange exhibit 30% section loss for 2'L x 3"W in front of the bearing area
